## A Case of Unexpected Stress

by Gordon Collyer

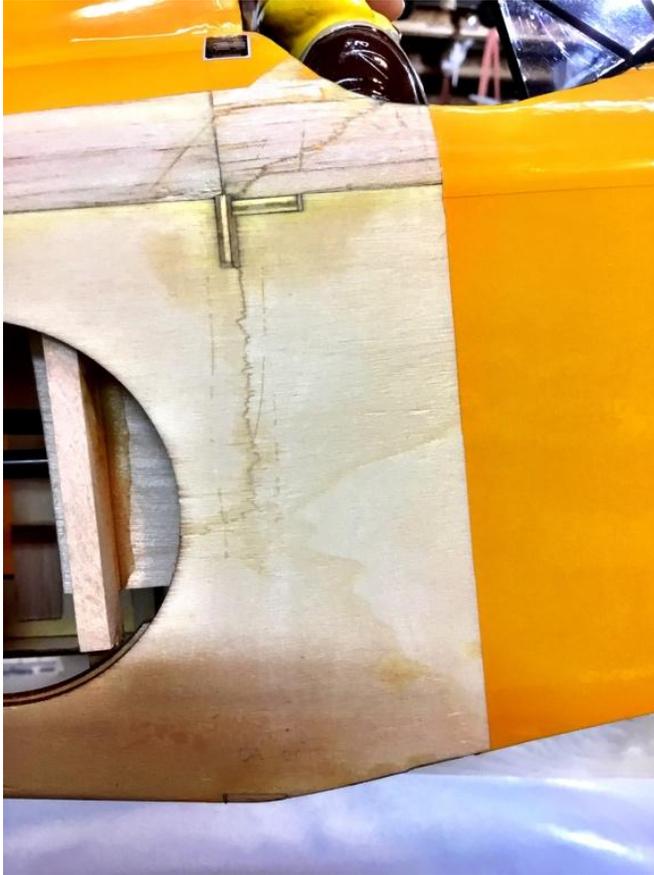
After two years of flying, my Hog Bipe developed unexpected cracks in the fuselage at the former where the sides begin the taper to the tail post. See below; forward is to the right in the picture.

tear in the Monokote on the left side at the mirror location that theory had to be abandoned. These tears looked more like "ruptures", with the fabric "bent" or feathered outward around the tear.

So, after the required fabric peel, the nearly symmetric cracks on both sides of the fuselage were revealed. There were small hairline cracks, apparently just through the outer skin of the lite-ply sides. Pressure on the fuselage aft of the cracks showed that they would move/widen. This and the fact that the Monokote was stressed to rupture show this was clearly not just cosmetic.

Stripping more covering to facilitate the mandated repairs refreshed my memory of the design, namely that the fuselage doubler in the Hog Bipe runs along the bottom of the fuselage only. The bend that results from the taper to the tail results in a more rounded bend on the bottom verses the top of the fuselage....so wherever the load on the airframe came from it stressed the top of the fuselage where there is no doubler and a comparatively sharper bend. Did the cracks occur during build and only rip the fabric due to more motion experienced in the recent landings? Did the cracks develop as the wood dried during low humidity over two winters? Were my snap rolls to "snappy"? I guess it will remain a
